Conductor cable externalization in an atrial hemodynamic sensor lead in a patient presenting with inappropriate shocks

Sing-Chien Yap, MD, PhD,^{*} Mark G. Hoogendijk, MD, PhD,^{*} Suzanne D.A. Valk, MD,[†] Sweder W. Van de Poll, MD, PhD,[†] Peter van der Kemp,[†] Tamas Szili-Torok, MD, PhD^{*}

From the ^{*}Department of Cardiology, Erasmus MC, University Medical Center Rotterdam, Rotterdam, The Netherlands, and [†]Department of Cardiology, Franciscus Gasthuis and Vlietland, Rotterdam, The Netherlands.

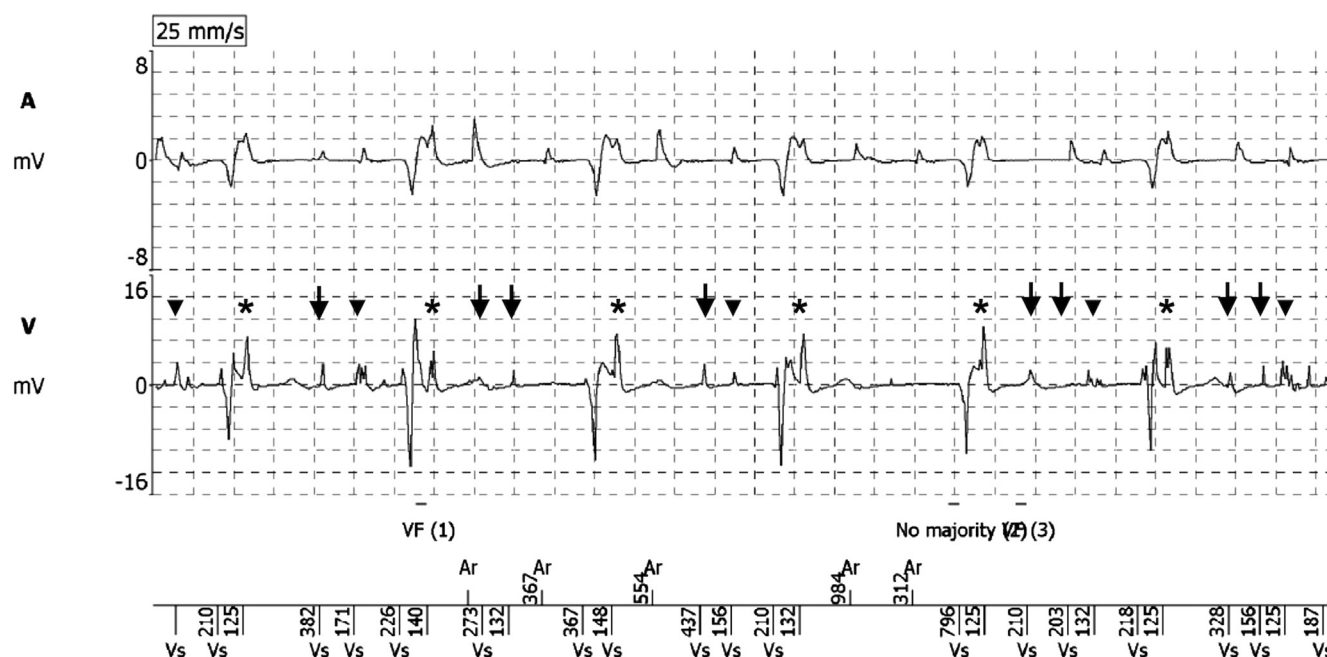
Figure 1 Electrogram just before the first inappropriate implantable cardioverter-defibrillator shock. Both the atrial (A) and right ventricular (V) channel showed discrete nonphysiologic noise. Discrete noise on the atrial channel was usually blanked out. Discrete noise on the ventricular channel was either peri-systolic (just after ventricular electric activation [asterisks]) or just before atrial electric activation [arrowheads]) or at random (arrows). Note that the noise is low in amplitude.

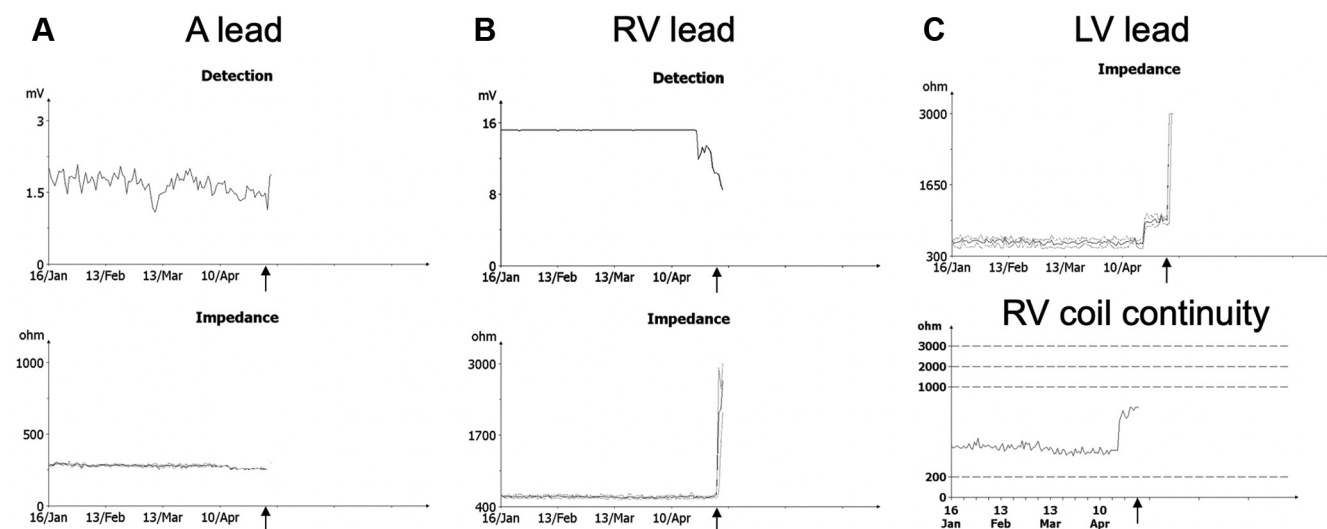
(Figure 2). Furthermore, there was a slight decrease in the atrial lead impedance preceding the abovementioned changes. On fluoroscopy, a fracture and protruding coil conductor cable was seen just proximal to the RV coil. Furthermore, externalization of conductors of the atrial lead was noted (Figure 3A). All leads demonstrated excessive slack.

Figure 2 Lead trends. **A:** Upper panel: atrial lead sensing amplitude; lower panel: atrial lead impedance trend. **B:** Upper panel: right ventricle (RV) lead sensing amplitude; lower panel: RV lead impedance trend. **C:** Upper panel: left ventricle (LV) lead impedance; lower panel: RV coil continuity. The period preceding the implantable cardioverter-defibrillator storm (arrow) was characterized by a progressive decrease in RV sense amplitude (suggesting insulation failure), a sudden increase in LV lead impedance (configured as LV tip to RV coil), and high voltage impedance. Note that the impedance of the atrial lead showed a slight decrease since mid-April.

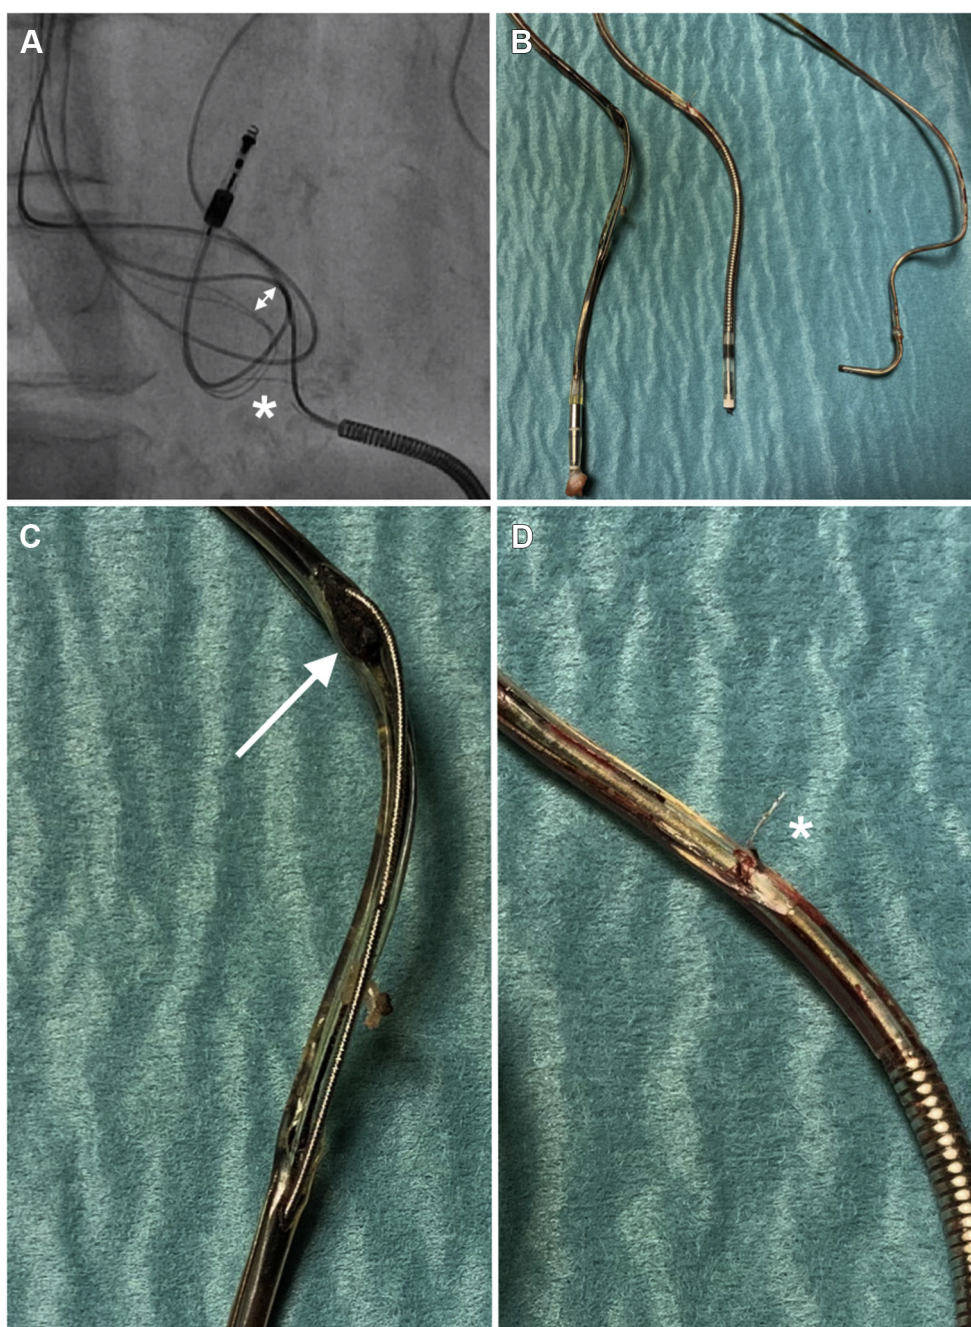
extraction tools (Figure 3B). Inspection of the extracted SonRtip atrial lead showed externalization of the pace coil over a distance of approximately 4.5 cm (Figure 3C). There was accumulation of biologic debris at the proximal site of the insulation breach. Inspection of the extracted Protego S lead demonstrated a conductor cable protruding through a breach in the silicone jacket insulation 1.5 cm proximal to the shock coil (Figure 3D). The insulation breach of the Protego S lead had smooth edges. As the patient had developed

Figure 3 Failed SonRtip (MicroPort, Shanghai, China) atrial lead and Protego (Biotronik, Berlin, Germany) defibrillator lead before and after extraction. **A:** Pre-extraction fluoroscopy demonstrating conductor cable externalization of the SonRtip lead (*double arrowheads*) and fracture and protrusion of the shock coil conductor (*asterisk*). **B:** Overview of the 3 extracted leads with, from left to right, SonRtip lead, Protego S lead, and QuickFlex (St. Jude Medical, St. Paul, MN) 1258T left ventricular lead. **C:** Detailed view of the SonRtip lead. Old, dark blood was seen in the lead body distant from the insulation breach. Note that the tip conductor coil is protruding out of the silicone body with accumulation of biologic debris and altered blood underneath the coil (*arrow*). There is a large insulation breach over a distance of approximately 4.5 cm. Additional cables remain within their lumens. **D:** Detailed view of the Protego S lead. Discrete breach in the silicone insulation proximal to the shock coil with protrusion of part of the shock coil conductor cable (*asterisk*).

to LV tip to RV coil). Interestingly, the insulation defect of the SonRtip lead was not associated with a significant change in electrical parameters before the ICD storm. During routine follow-up there was only mild attenuation of the atrial signal and mild augmentation of the ventricular far-field signal causing inappropriate mode switch episodes. The breach in the insulation jacket of the SonRtip atrial lead was large, with ragged edges. The build-up of biological debris underneath the pace coil (arrow, [Figure 3C](#)) clearly suggests a pre-existing insulation breach that was not caused by the extraction procedure. The mechanism of CCE is most likely IOA.
