Possible leakage radiation during malfunctioning of a Sagittaire accelerator

E. Woudstra*, H. Huizenga, J.A. van de Poel

Department of Clinical Physics, Dr Daniel den Hoed Cancer Center, Groene Hilledijk 301, 3075 EA Rotterdam, Netherlands

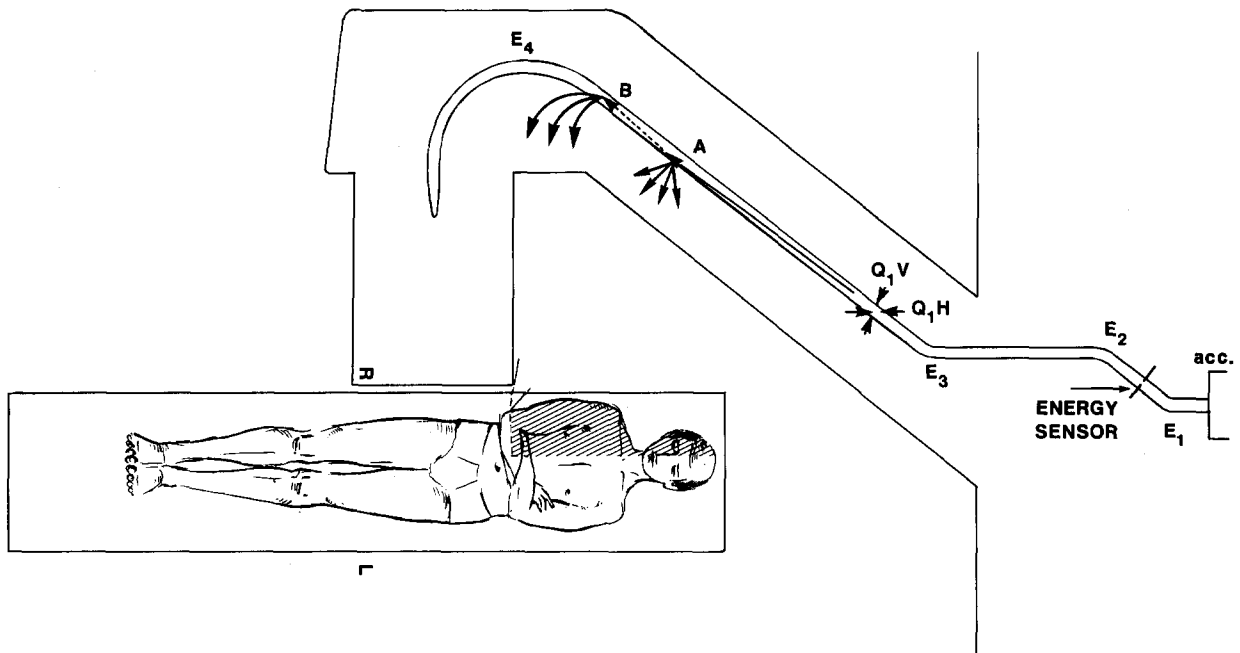
Fig. 1. Sketch indicating: patient position during irradiation with the most likely gantry position for the explanation of the skin reaction produced by leakage radiation (nearly horizontal at the right side of the patient); area of significant skin reaction observed after the irradiation period; a global drawing of the energy regulation and beam bending and transport system; and hypothesis for generation of leakage radiation.

The most probable position and direction of the leakage radiation source was reconstructed from the region of skin reactions related to the most likely gantry and collimator position of the accelerator under the treatment set-up conditions. From this reconstruction it was concluded that the leakage radiation source was located at the upper end of the beam guiding tube close to the last part of the bending system (see Fig. 1). If the leakage radiation originated in the beam guiding tube it should have been able to penetrate the almost 3-cm thick plastic gantry cover.

This energy increase depends on the phase difference between the two parts. Energy regulation and beam transport is done in the system beyond the accelerator, where the electrons pass through an energy regulation part which consists of a bending magnet (E_1) and an energy sensor which controls the input RF power (see Fig. 1.).

Two additional bending magnets (E_2 and E_3) lead the electrons into the beam guiding tube of the gantry and, finally, the bending magnet (E_4) bends the beam into a strictly vertical direction through the head of the accelerator. The electron beam transport in the beam guiding part of the gantry is supported by centering magnets, Q_1H and Q_1V , that lead the electrons to the input position for bending system E_4 .

Apart from the use of a dose rate interlock circuit, an additional precaution might be the use of a lead shield along the beam guiding tube on the side of the patient. In this case it might have largely decreased the dose rate of this leakage radiation to the patient. Moreover, an additional leakage radiation measuring system close to the unshielded beam guiding tube might also have prevented this accident.
