# Multipane/3D transesophageal echocardiography monitoring to improve the safety and outcome of complex transvenous lead extractions

Both transesophageal echocardiography (TEE) and intracardiac echocardiography have been used to assist transvenous lead extractions. The clinical utility of continuous echocardiographic monitoring during the procedure is still debated, with different reports supporting opposite findings. In cases where the procedure is expected to be difficult, we propose adding a continuous TEE monitoring using a static 3D/multipane probe in mid-esophageal position, with digital remote manipulation of the field of view. This approach may improve the chances of a successful extraction, increase safety, or even guide the entire intervention. We present here a short case series where continuous monitoring by TEE played an important role.

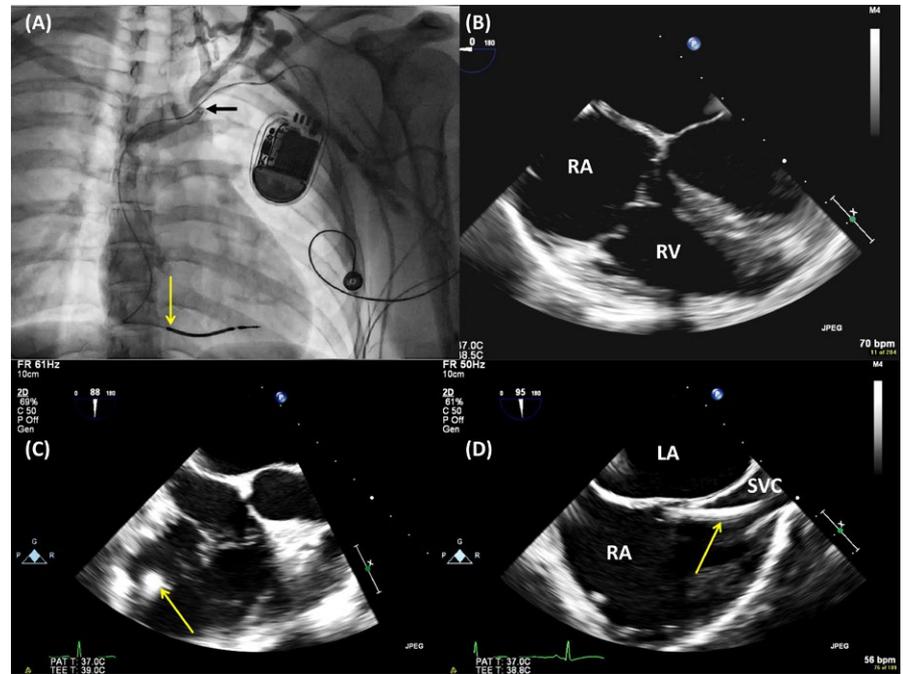
**FIGURE 1** A, Left arm phlebography. The subclavian vein stops abruptly (dark arrow), with collateral filling visible above; the right ventricular lead is indicated with a yellow arrow. B, In 2D transesophageal 4-chamber view, the lead was difficult to image being situated very posteriorly; C, in short axis of the tricuspid valve, the lead becomes visible; D, bicaval view, demonstrating the relation between the lead and the superior vena cava

of electrical noise resulting in aborted shocks and needed to be replaced. On left arm phlebography, a total occlusion of the left subclavian vein in its mid-portion was noted, probably in relation to the presence of the lead. Venous return from the left arm followed a collateral supraclavicular system to join the more proximal left subclavian (Figure 1). Because of the venous occlusion, endovascular adhesions were suspected along the lead and we decided to perform the intervention under TEE monitoring. The shock lead was difficult to visualize with 2D echocardiography because of its position in the posteroseptal commissure. Switching to 3D imaging allowed clear visualization of the lead course, from the terminal part of the superior vena cava (SVC), through the tricuspid valve, and up to the right ventricular (RV) apex (Figure 2, Movie S1). No venous or valvular adhesions were noted. Because of a very narrow subclavian passage, but without any venous adhesions, the lead was extracted via

felt while pulling on the lead, a free-floating lead is very likely. In the presence of occlusion in the innominate vein (case 1), this maneuver is not useful. In this case, TEE was useful to demonstrate the absence of vascular and valvular adhesions from the level of the SVC to RV. Snaring the lead was deemed the most logical option in this case.

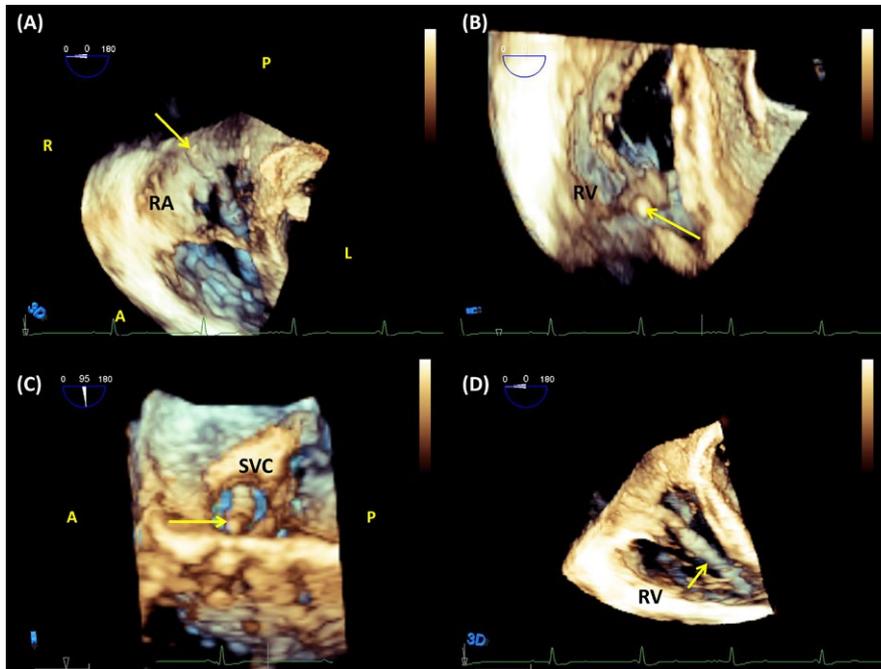
**FIGURE 2** A, On tridimensional echocardiography, the lead was easily identifiable in the posterior commissure of the tricuspid valve from the right atrial aspect of the valve; B, the lead is free from adherences to the valve, coursing further to the apex of the right ventricle (RV). C, Transversal view of the superior vena cava demonstrated a lead (arrow) moving freely from the venous walls; D, RV segment of the lead, visible up to the apex

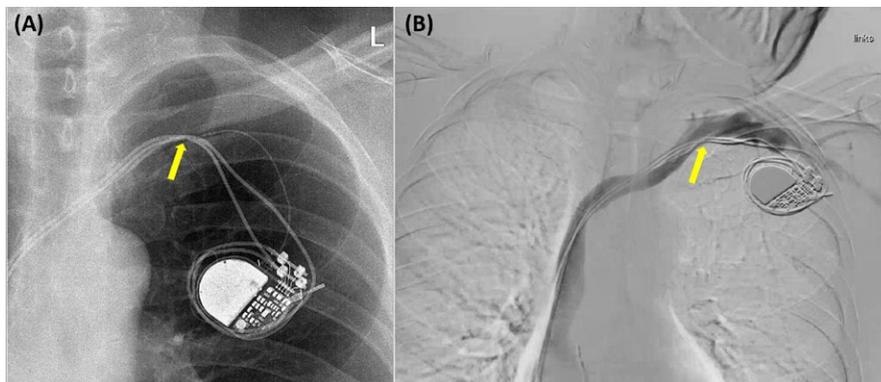
**FIGURE 3** A, crushed leads (arrow) in the subclavian passage, visible on focused X-ray. Note the presence of three leads (two active leads and one old inactive right ventricular lead); B, left arm phlebography confirming the crush

A 69-year-old man with sick sinus syndrome had a dual-chamber pacemaker implanted in 2010. Shortly after implantation, both leads became dysfunctional. During the first extraction, both leads were replaced but only the atrial lead could be removed. The old RV lead was abandoned. In 2017, the new leads also became dysfunctional. The chest X-ray and left arm phlebography showed signs of subclavian crush syndrome (Figure 3). The presence of three relatively old leads was considered to complicate the extraction procedure, which was then performed under continuous TEE monitoring (Figure 4). The locking stylet could not be inserted in the leads (probably due to the subclavian crush); thus, a femoral approach with a snare tool (Needle's-Eye Snare, Cook Medical) was chosen. The atrial lead was extracted with ease as well as the most recent implanted RV lead. During careful but progressive pulling of the abandoned RV lead, we saw near inversion of the RV cavity with TEE (Figure 4). In this short period, the blood pressure dropped but quickly recovered after the lead detached and the RV re-expanded (Movie S2). The patient was re-implanted with a new dual-chamber pacemaker (Figure 5). No complication was noted, and the patient was quickly discharged.

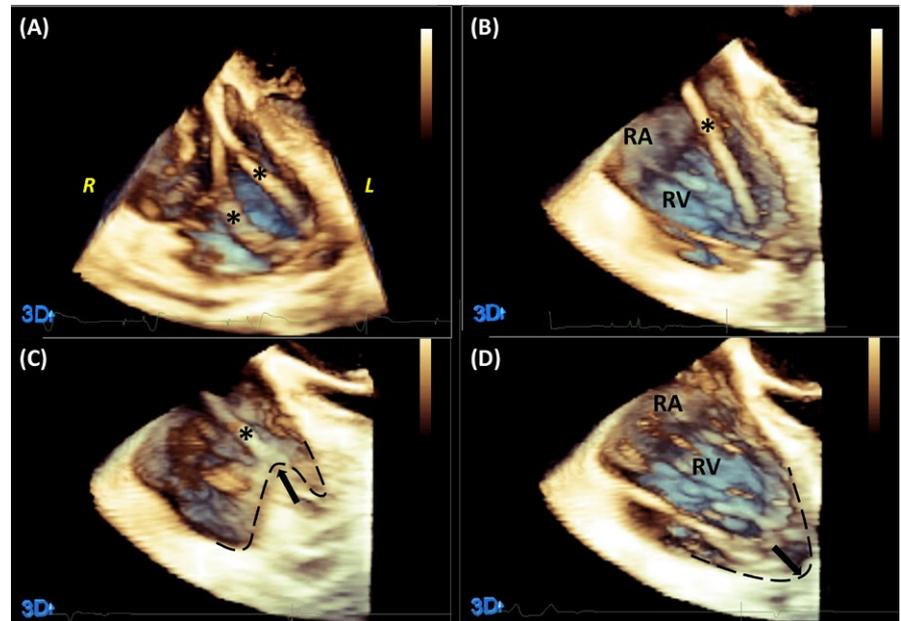
**FIGURE 4** 3D echocardiography focused on the right ventricle (RV) and right atrium during the ventricular lead extraction. A, Start of the procedure, with the two RV leads in situ (asterisk). B, The first lead was easily extracted; C, near inversion of the RV cavity (arrow, dashed contour) during pulling of the last lead; D, RV cavity re-expanded after the lead detached (arrow, dashed contour)

Transesophageal echocardiography is also useful for rapidly identifying or excluding cardiovascular causes of hemodynamic instability during a TLE procedure.<sup>3,5,10</sup> It is especially useful for monitoring pericardial effusion. Another important cause of hemodynamic instability is impairment of venous return during controlled pulling on the leads as demonstrated by case 2. RA or RV retraction limits venous return and lowers LV filling causing hypotension. Hemodynamic stability is acquired by releasing pulling pressure or successful extraction.

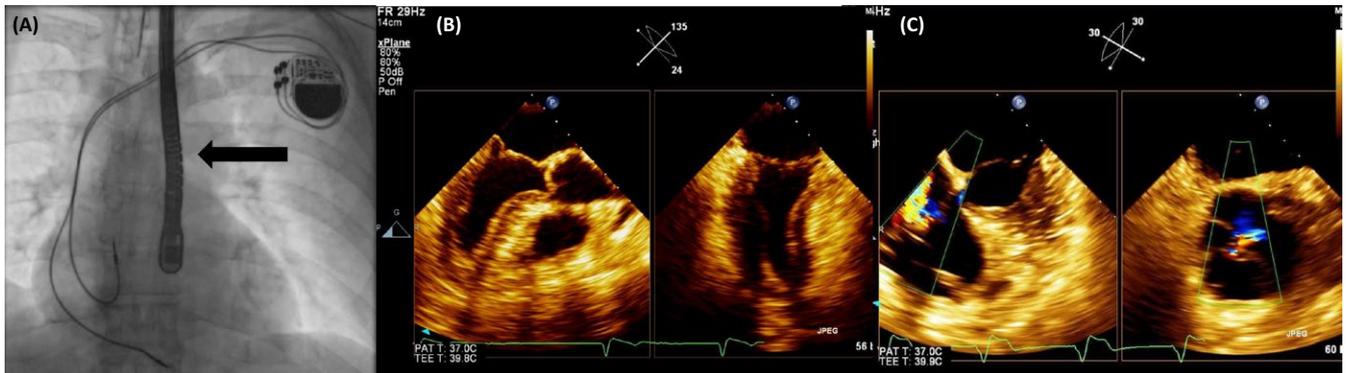
**FIGURE 5** Postimplantation of the new leads. A, Position of the new leads. The static echocardiography probe is also visible in mid-esophageal position (arrow); B, biplane image of the left cavities; C, biplane image of the tricuspid valve (left long axis, right short axis), displaying a stable pre-existent tricuspid valve regurgitation. Note that both the left and the right cavities could be imaged in multiplane, by remotely manipulating the field of view, without altering the probe position

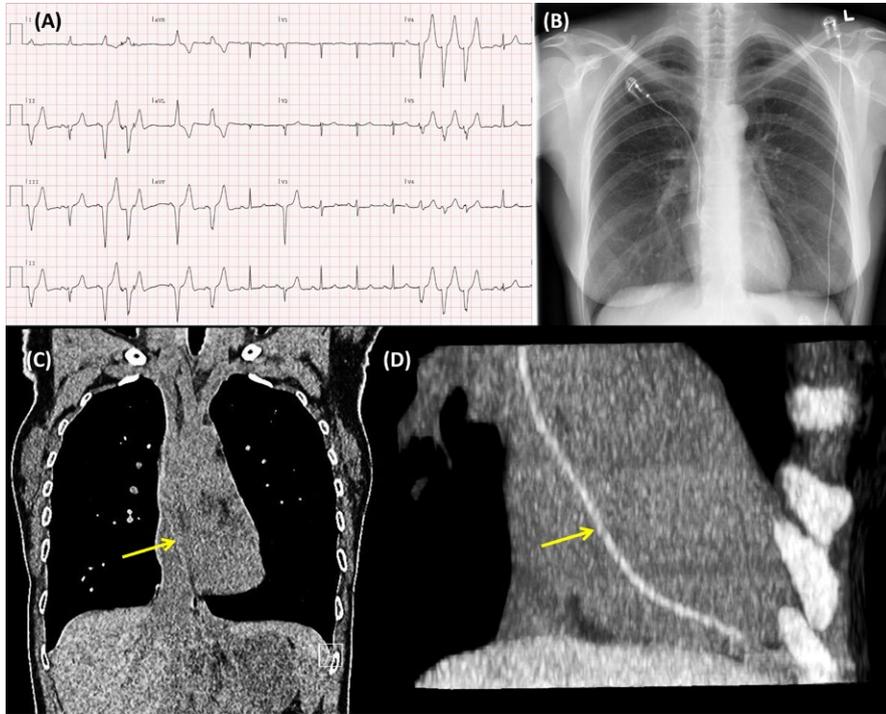
**FIGURE 6** A, ECG sinus rhythm with frequent multifocal premature ventricular complexes; B, normal thorax X-ray, no lead fragment could be seen; C, CT scan frontal plane, focused on the caval veins: A linear structure (arrow) could be noticed in the proximal superior vena cava. D, CT focused oblique view of the right atrium and right ventricular, demonstrating the linear structure (arrow) coursing to the apex of the right ventricle

full-system dual-chamber pacemaker extraction. No pacemaker was re-implanted due to the absence of pacing in the previous 5 years. Her ECG at presentation showed sinus rhythm with frequent multifocal premature ventricular complexes and short runs of ventricular tachycardia. Her chest X-ray was normal and did not demonstrate a complication of the recent lead extraction. On transthoracic echocardiography, a very weak linear echo was visible (Movie S3) in the right atrium (RA). A thoracic CT scan was performed, and a linear structure could be noticed coursing from the proximal SVC to the RV apex (Figure 6). The most probable diagnosis was a retained fragment of the silicone insulation of the previous extracted RV lead. After discussing the case in a heart team, it was decided to try a TEE-guided percutaneous removal. Surgical removal remained as an escape option. The retained silicone sheath could not be visualized with high-intensity fluoroscopy; thus, the extraction was guided by TEE. By 3D and multiplane imaging, the silicone insulation sheath was visible from the terminal part of the superior vena cava (Movie S4), coursing through the RA, the tricuspid valve, and ending in the RV apex, "trapped" into the complex trabeculae but without being firmly attached (Figure 7). The upper end of the fragment was found floating freely in the last 4 centimeters of the superior vena cava, clearly visible on multiplane and 3D TEE (Figure 8, Movie S4). A snare tool (Needle's-Eye Snare, Cook Medical) was guided into the RA using fluoroscopy. Thereafter, guiding was performed using multiplane/3D echocardiography alone, from a modified bicaval view. The snare tool was advanced into the SVC, and the retained silicone sheath was snared and removed (Figure 8, Movie S5). Extraction was complete, confirmed by visual inspection of the insulation fragment and TEE. The patient had no recurrence of ventricular arrhythmia, despite discontinuation of antiarrhythmic drugs. She was quickly discharged to outpatient follow-up.

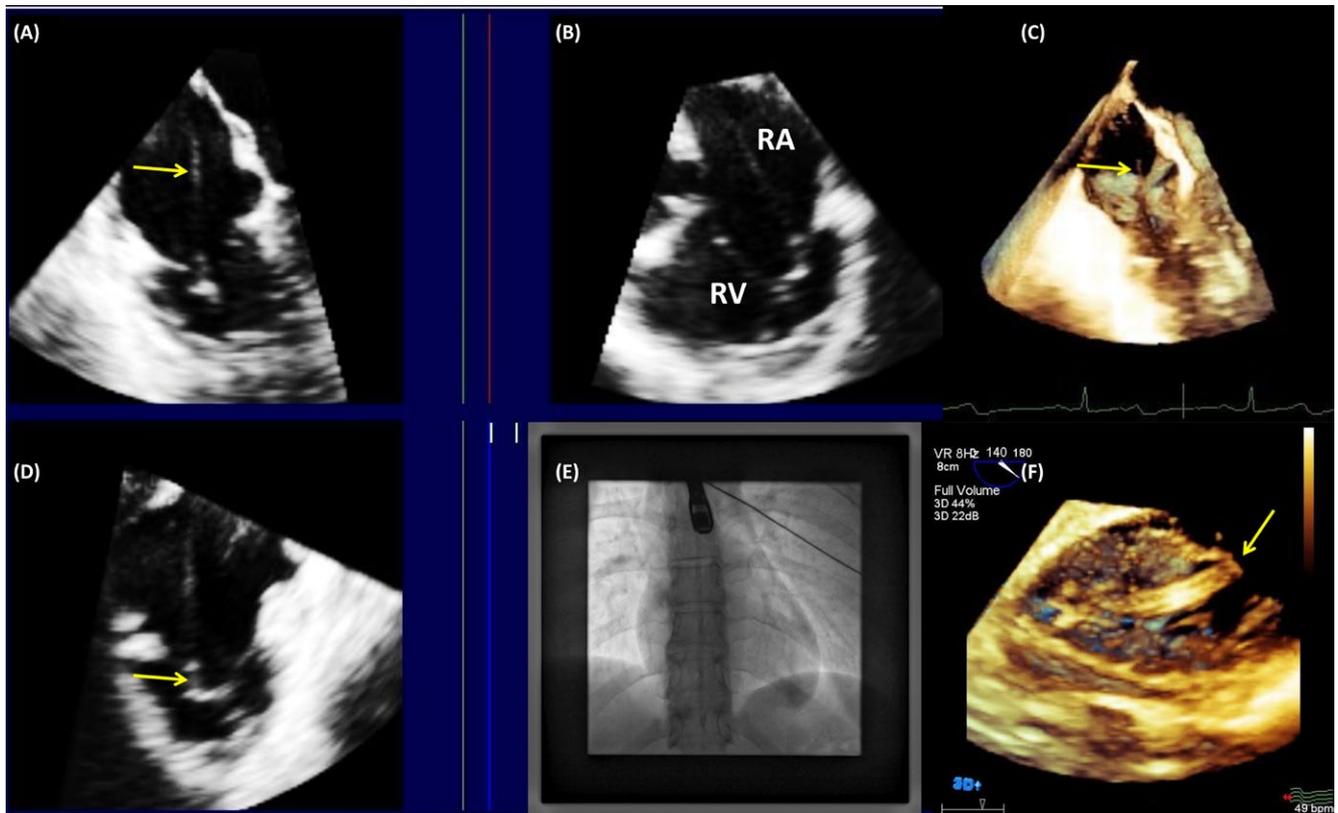
**FIGURE 7** 3D and multiplane sections of the right cavities demonstrating the presence of the radiotransparent insulation sheath. A, B, D, triplane sections of right atrium (RA) and right ventricular (RV). The silicone insulation sheath is coursing through the right atrium, the tricuspid valve, and ending in the right ventricular apex (F, arrow); C, 3D view of RA and RV in mid-esophageal position, the insulation sheath is also visible as an relatively weak but clear linear echo (arrow); E, with high-resolution angiography, the sheath could not be seen

fracture due to mechanical stress during extraction and become obvious on fluoroscopy checkup. Cases have been described of remaining fragments of the silicone protective tube around the lead. These can easily be missed by fluoroscopy if no metallic fragment is retained.<sup>12,13</sup> Echocardiography however is an ideal imaging tool in this clinical scenario, given the relatively high contrast between intracavitary blood and any type of solid foreign body. This is illustrated by our Patient 3 in whom, although a multimodality approach was needed for the diagnosis, TEE was the only intraprocedural imaging tool allowing successful guidance of the TLE procedure.

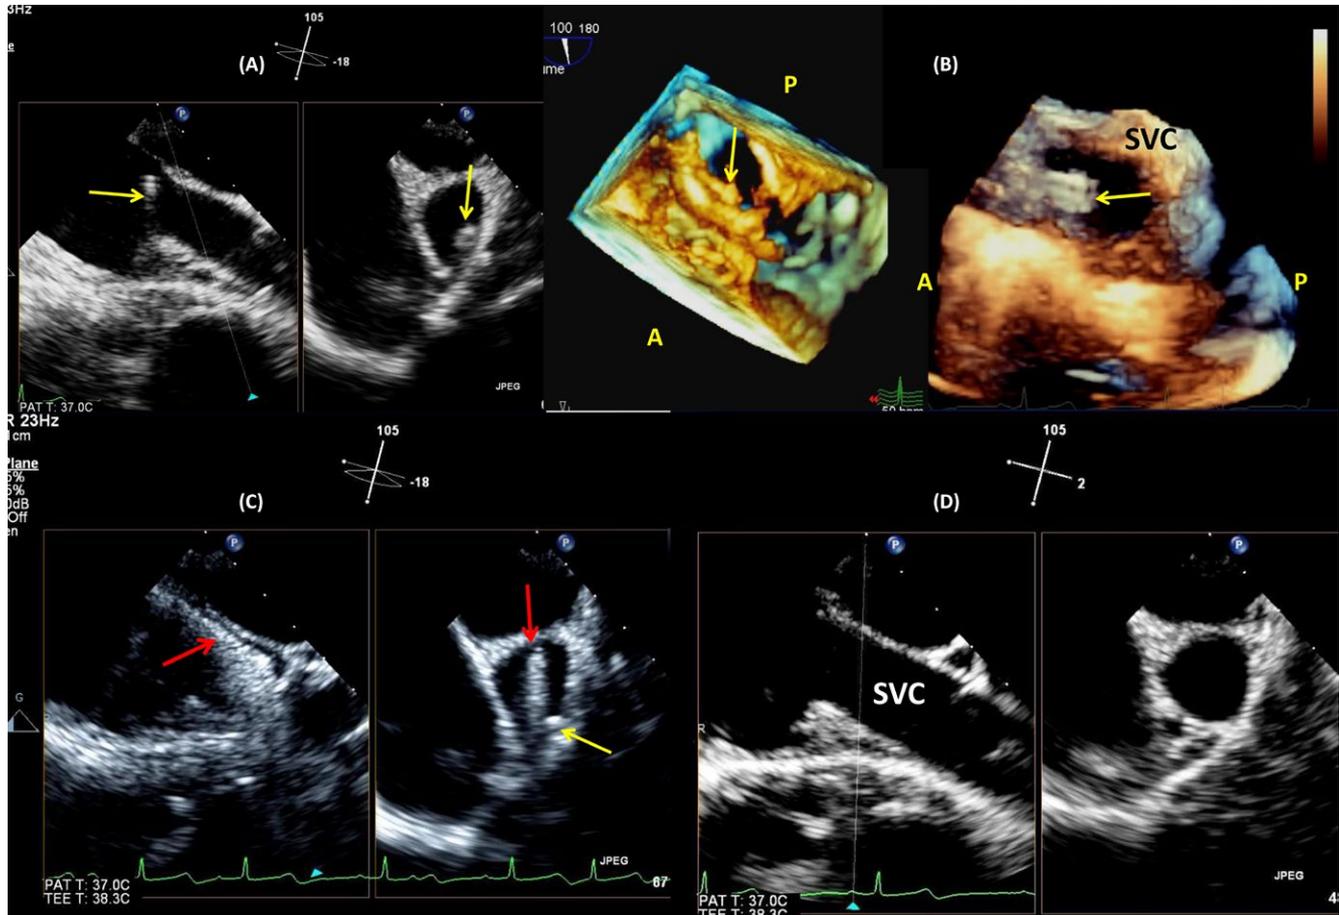
**FIGURE 8** Multiplane/3D echocardiography guiding the extraction. A, biplane image of the superior vena cava (SVC), with the silicone sheath visible (arrow); B, 3D biplane images of the free upper end of the sheath in the last 4 cm of the superior vena cava; C, modified biplane bicaval view: the extraction tool (red arrow) and the free upper end of the sheath (yellow arrow) seen in the superior vena cava; D, following the procedure, the SVC is free of any echos
